**LABORATORY TEST REPORT
LB 39-20**

Test Specimens: Level 1 Polyethylene Pneumatic Dunnage Bags

Test Procedure: (Extracted from General Information Bulletin No. 9, *Product Performance Profile for Pneumatic Dunnage*.)

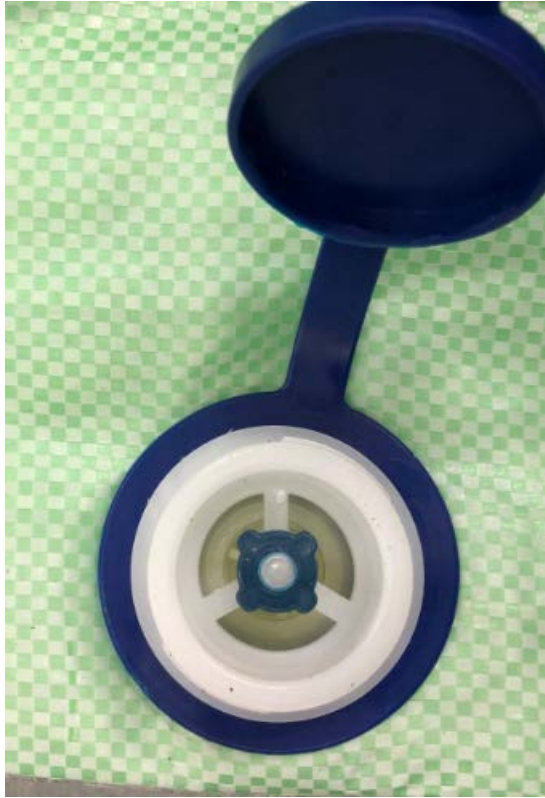
Photo 1: Inflation Valve
